# **Evaluation of Field-deployed Low Cost PM Sensors**

National Exposure Research Laboratory Office of Research and Development U.S. Environmental Protection Agency Research Triangle Park, NC, USA 27711

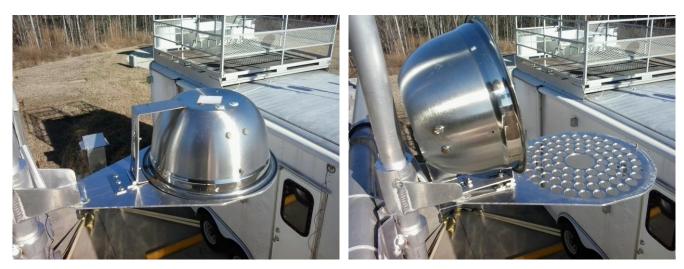
Figure 2-1. "Bowl on pole" sensor enclosure in closed (left) and open (right) positions.

"Bowl on pole" sensor shelters were devised and constructed for the field evaluations. The shelters, shown in Figures 2-1 through 2.1-2, were constructed in-house of aluminum. Thermostated thermal heating pads were attached to the tops of the bowls in an attempt to maintain interior shelter conditions where the sensors were housed at or above 6° Celsius. Even so, it must be recognized that these heaters were purposefully selected to provide for a minimal degree of general heating and that internal temperatures of the sensors registering at or just below freezing were sometimes observed. These aforementioned enclosures were constructed to ensure sensor protection from windblown rain as well as direct sunlight upon the inlets of the devices. The shelters did not fully protect the inlets of the devices from the effects of any face velocity issues (wind speed and/or its direction). Even so, the interface of the sensor inlet did attempt to place a shield between the immediate sensor inlet opening and the ambient atmosphere. That shield is viewable in Figure 2-1 with the sensor often placed directly above or its inlet in one of the openings to provide unencumbered access to ambient conditions. Effects of sensor PM starvation or stagnation would not be expected to have occurred under the test conditions.

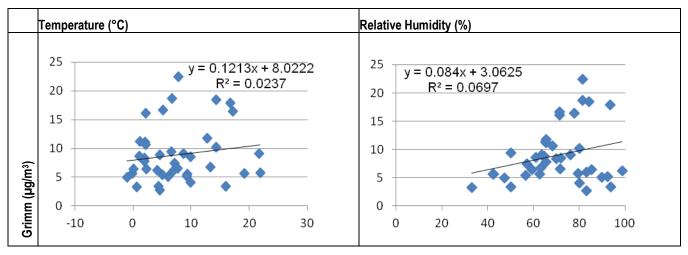
Figure 2.1.1-1. Grimm data vs. temperature and RH.

covered under a QAPP for that study<sup>8,9</sup>. Data from the Grimm were available during the data collection period of the sensor evaluation as 1-min, 5-min, or 60-min averages. Sensors tested in this study featured time resolutions between 1-s and 5-min. We selected a matched data integration period (average) of 5 minutes for comparison with the sensors. General relationships between the Grimm response and environmental conditions are reported in Figure 2.1.1-1.

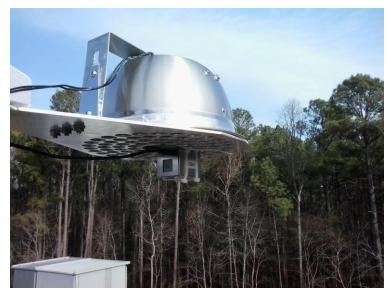
Figure 2.1.3-1. CairClip PM sensor suspended beneath shelter grating.

The CairClip was originally placed on top of the shelter grating with the inlet flush to a hole in the grating. On December 13, 2013, following a review of the data in hand (relatively low concentrations being reported), it was suspended underneath the grating with zip ties, as shown in Figure 2.1.3-1, to maximize airflow. The reason for this being the concern that inadequate fresh air supply (stagnation) might be the cause of a lack of observed day-to-day PM concentration variability with this sensor. The repositioning of the sensor to a fully open nature

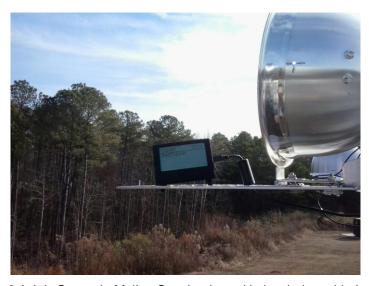
Figure 2.1.4-1. Carnegie Mellon Speck oriented in its shelter with the lid up.

Because the Carnegie Mellon Speck's inlet is on its bottom surface, it was simply placed on the grating as shown in Figure 2.1.4-1. The Speck experienced two interruptions in data collection, both of which began while the operator was in the field. This suggests that it failed to restart data collection after a data download was completed. This might be the result of operator error and not necessarily the fault of the device.

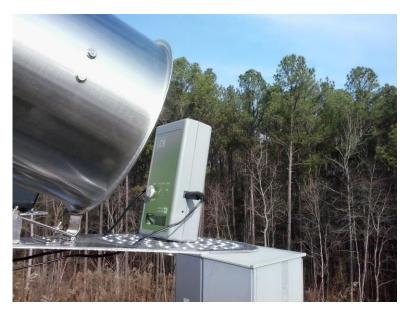
Figure 2.1.6-1. Met One model 831 oriented in its shelter with the lid up.

The Met One model 831 was positioned upside down so that its inlet protruded beneath the grating of its shelter as shown in Figures 2.1.6-1 and 2.1.6-2. The Met One experienced one interruption in sampling, which began while the operator was in the field. This suggests that it failed to restart data collection after a data download was completed. This might be the result of operator error and not necessarily the fault of the device.

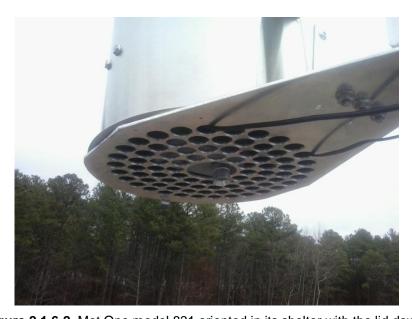
Figure 2.1.6-2. Met One model 831 oriented in its shelter with the lid down.

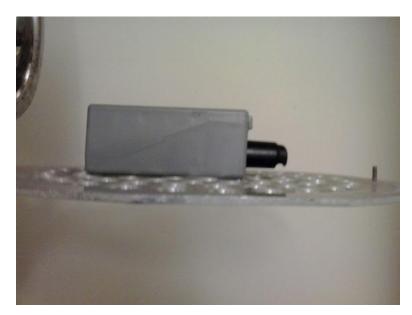
Figure 2.1.7-1. RTI MicroPEM orientation on the plate of a bowl-on-pole shelter.

The RTI MicroPEM is an optical particulate matter sensor that uses a size-selective inlet to measure PM<sub>2.5</sub>. Three RTI MicroPEM units were simultaneously tested from July 29 through September 2, 2014 at the AIRS sampling site. On the advice of the manufacturer, they were arranged in the bowl-on-pole shelters as shown in Figure 2.1.7-1. As shown, they are placed on the grating on their side with the opening to the nozzle facing down. Each MicroPEM unit was

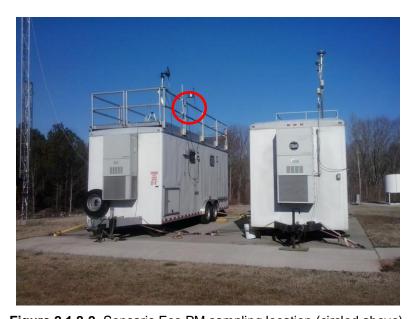
**Figure 2.1.8-2.** Sensaris Eco PM sampling location (circled above).

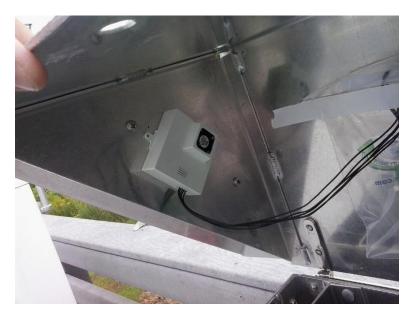
**Figure 2.1.9-1:** Shinyei in a Hi-Vol shelter. Note that the lid to the Hi-Vol shelter was closed during sampling.

interference. Whenever the sun was shining, the unit reported nearly  $800~\mu g/m^3$ . As such, the initial test was discarded and the unit relocated to a Hi-Vol shelter where it would be better protected from sunlight. The position and orientation of the unit in the second test is shown in Figure 2.1.9-1. The unit was attached to the lid of the Hi-Vol shelter via double-sided tape.

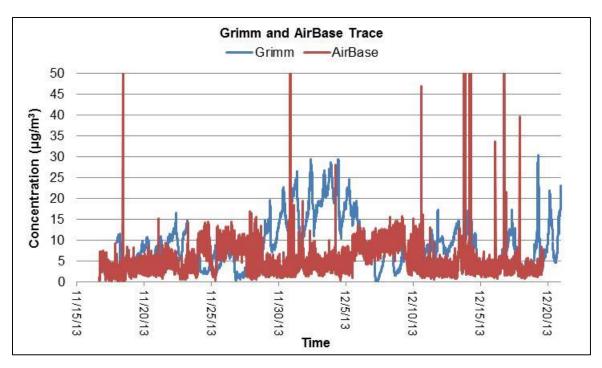
Figure 3.1.1-1. Grimm and AirBase data over time.

The trace of the AirBase PM sensor data does not appear to follow that of the Grimm FEM analyzer. Scatter plots show that the AirBase PM data had minimal correlation with the Grimm or with any other factors. No speculation can be provided as to why this lack of agreement was observed.

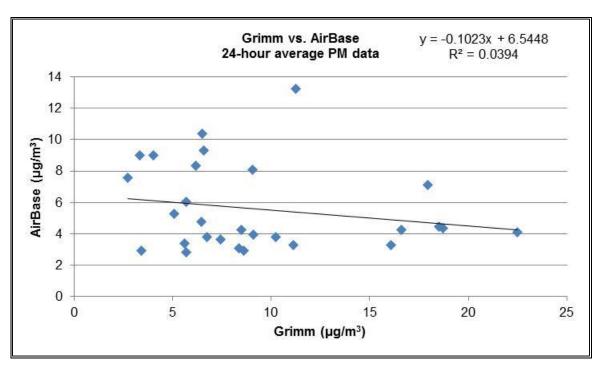
**Figure 3.1.1-2.** 24-hour time-averaged PM data comparing the Grimm reference sampler with the AirBase CanarIT PM sensor.

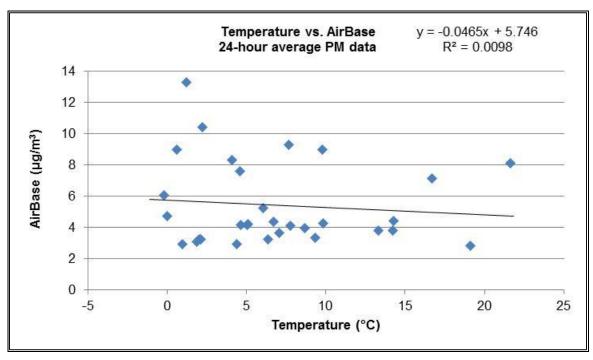
Figure 3.1.1-3. Temperature vs. AirBase 24-hour averaged data.

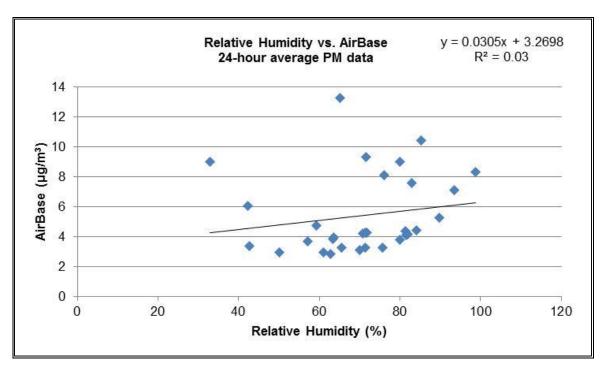
Figure 3.1.1-4. RH vs. AirBase 24-hour averaged data.

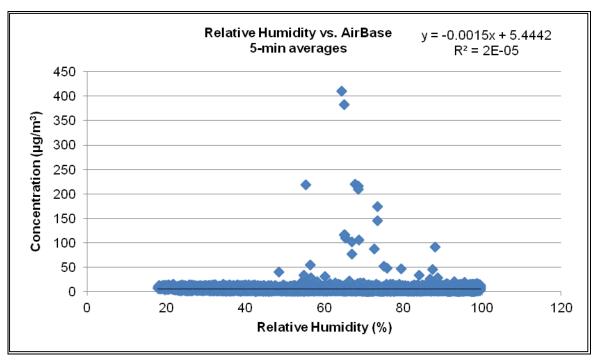
Figure 3.1.1-5. RH vs. AirBase (5-min averages).

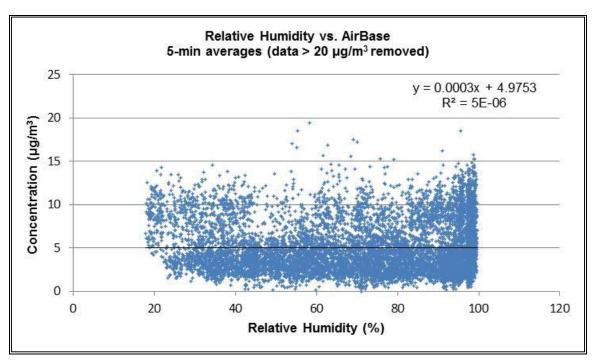
**Figure 3.1.1-6.** RH vs. AirBase (5-min averages) with data >  $20 \mu g/m^3$  removed.

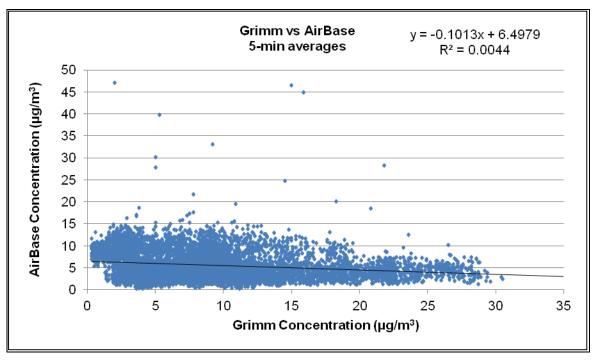
Figure 3.1.1-7. Grimm vs. AirBase (5-min averages).

Given the data detailed above, no basis for any correction factors or removal of outliers can be found. The final scatter plot of Grimm vs. AirBase data is shown below in Figure 3.1.1-7. The scale has been chosen manually to better illustrate the bulk of the data.

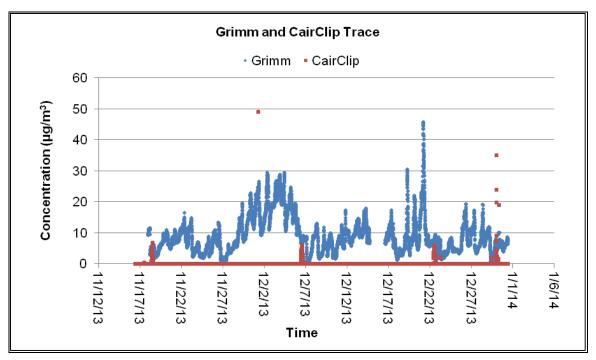
Figure 3.2.1-1. Grimm data and CairClip data over time.

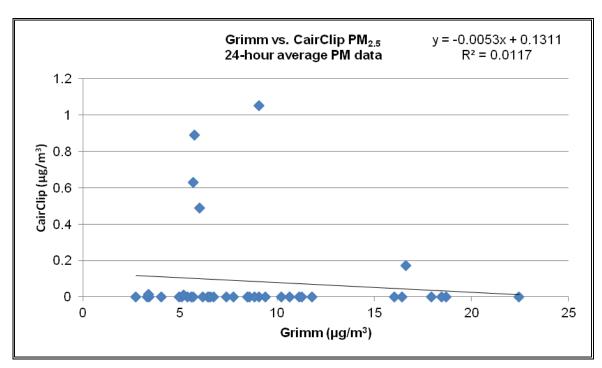
**Figure 3.2.1-2.** 24-hour time-averaged PM data comparing the Grimm reference sampler with the CairPol CairClip PM sensor.

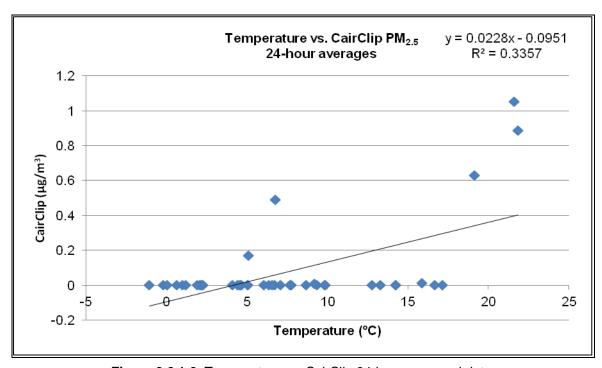
Figure 3.2.1-3. Temperature vs. CairClip 24-hour averaged data.

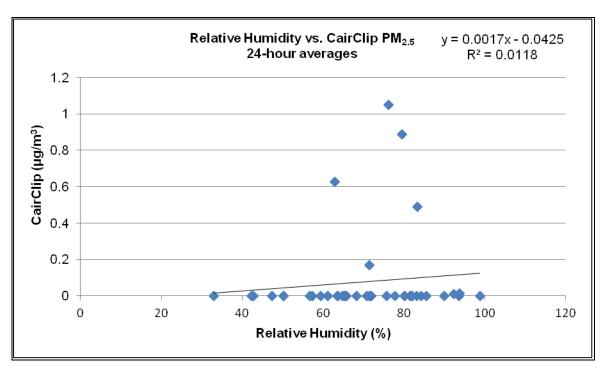
Figure 3.2.1-4. RH vs. CairClip 24-hour averaged data.

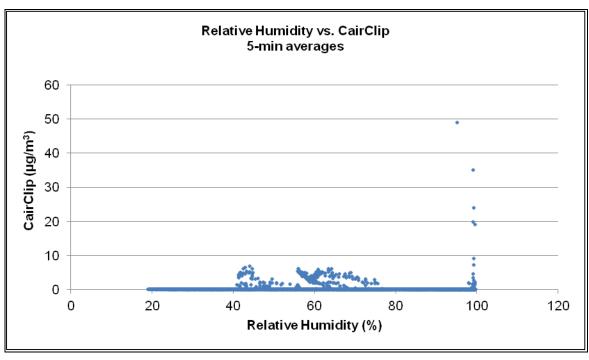
Figure 3.2.1-5. RH vs. CairClip (5-min averages).

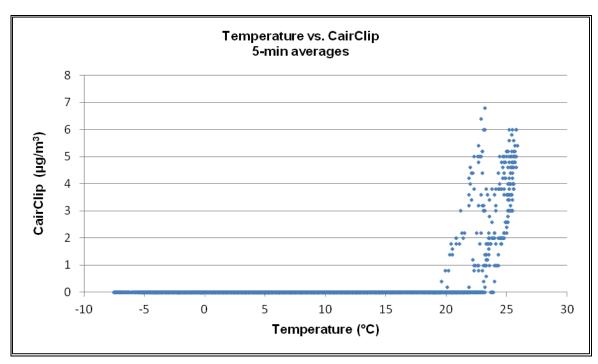
**Figure 3.2.1-6.** Temperature vs. CairClip (5-min averages). All data taken at humidities > 95% were removed.

As shown in Figure 3.2.1-6, the CairClip produced detectable responses only at temperatures above 19.8 °C. Figure 3.2.1-7 is the same graph using only data at temperatures above 19.8 °C. This clearly shows correlation between temperature and the CairClip signal. Figure 3.2.1-8 shows that even with high humidity and low temperature data removed, no clear correlation is observed between the CairClip and the Grimm FEM data.

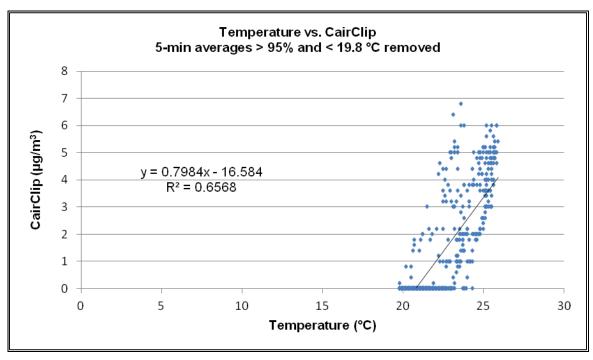
**Figure 3.2.1-7.** Temperature vs. CairClip (5-min averages). All data taken at humidities > 95% and temperatures < 19.8 °C were removed.

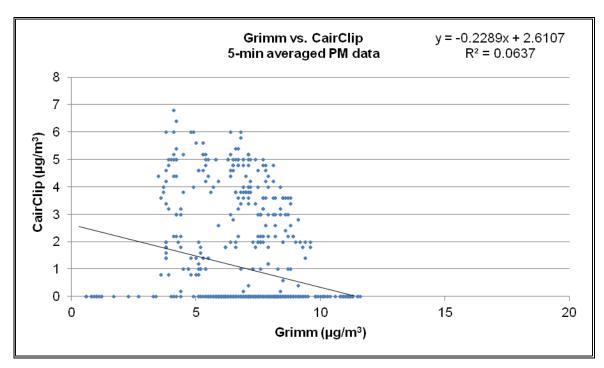
Figure 3.2.1-8. Grimm vs. CairClip (5-min averages).

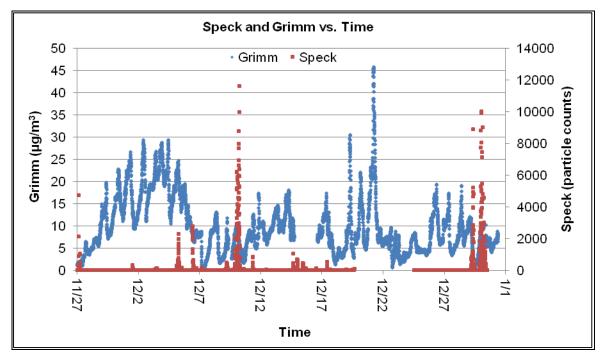
Figure 3.3.1-1. Speck data and Grimm data over time.

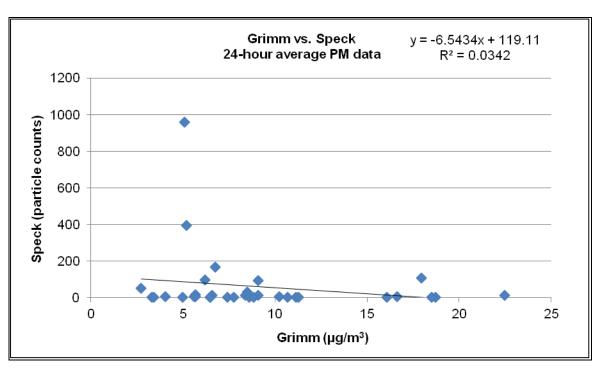
Figure 3.3.1-2. 24-hour time-averaged PM data comparing the Grimm reference sampler with the Speck.

The 24-hour averaged data depicted in Figures 3.3.1-2 through 3.3.1-4 suggest a strong correlation with humidity that is likely obscuring any correlation that might be present with temperature and the Grimm. Relative humidity can change rapidly over the course of a day, necessitating a further examination of the correlation between humidity and sensor response at the 5-min averaged time resolution, as shown in Figure 3.3.1-5.

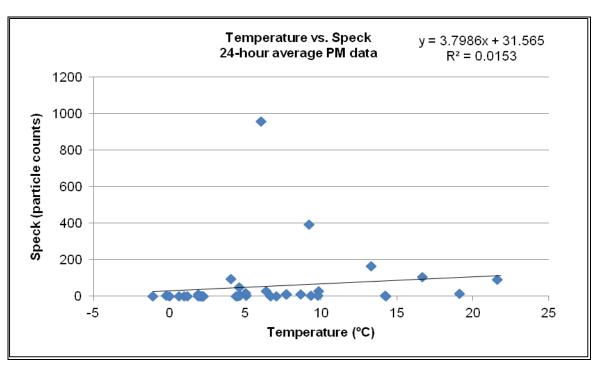
Figure 3.3.1-3. Temperature vs. Speck 24-hour averaged data.

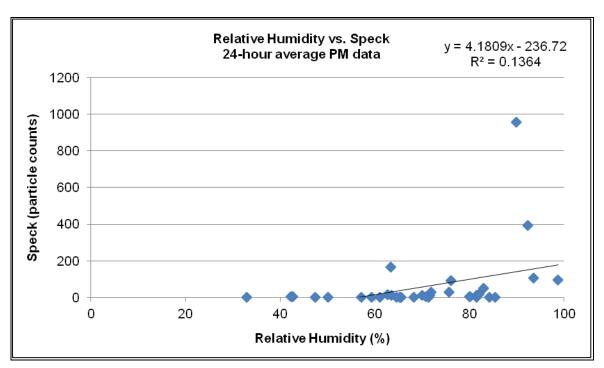
Figure 3.3.1-4. RH vs. Speck 24-hour averaged data.

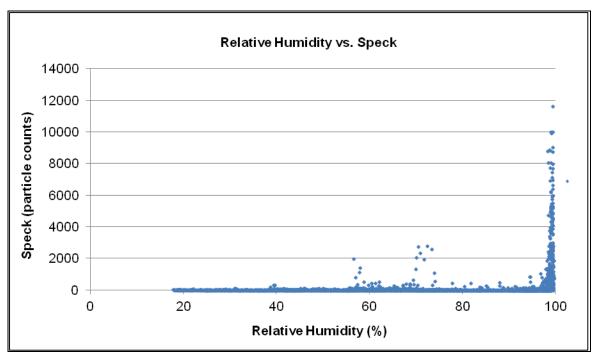
Figure 3.3.1-5. RH vs. Speck (5-min averages).

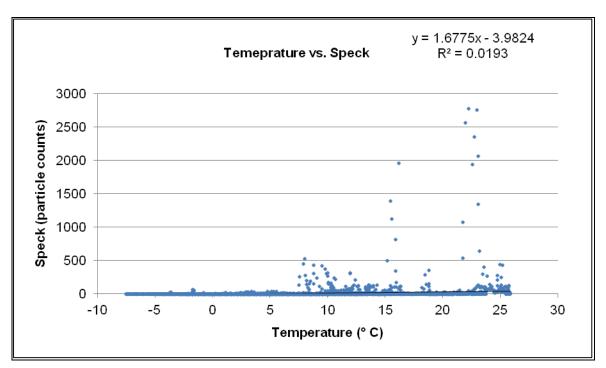
Figure 3.3.1-6. Temperature vs. Speck (5-min averages).

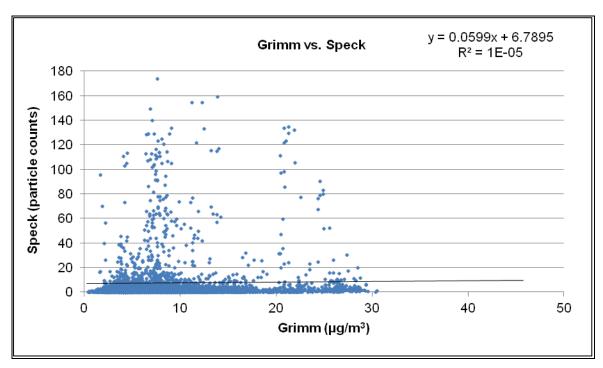
Figure 3.3.1-7. Grimm vs. Speck (5-min averages).

Many attempts were made to associate the remaining spikes to a factor that could be corrected for or removed, but these attempts were unsuccessful. Taking the square root or the log of the Speck data was also futile. With no clear method to identify additional outliers, the plot of Speck vs. Grimm data in Figure 3.3.1-7 shows no correlation.

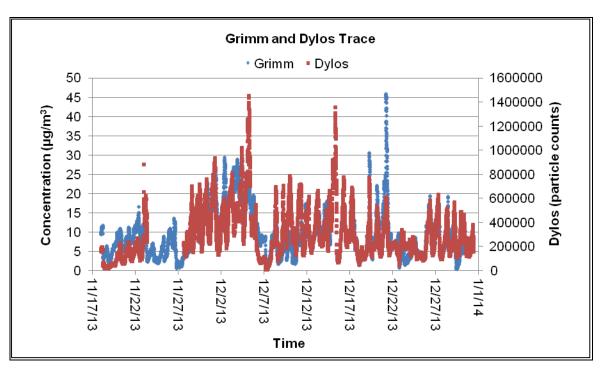
Figure 3.4.1-1. Grimm data and Dylos data over time.

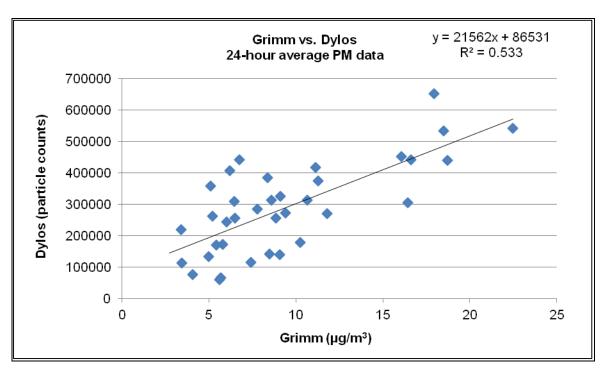
**Figure 3.4.1-2.** 24-hour time-averaged PM data comparing the Grimm reference sampler with the Dylos DC1100 PM sensor.

different units on dramatically different scales. This comparison is further explored quantitatively with the DC1100 24-hour averaged data plotted against the Grimm reference data (Figure 3.4.1-2) as well as temperature (Figure 3.4.1-3) and RH (Figure 3.4.1-4). The 24-hour average data suggest a strong correlation with the Grimm reference data. No correlation with temperature was observed while a potential correlation with humidity was evident.

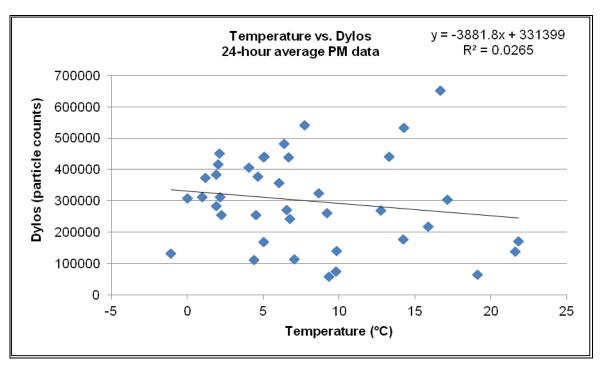
Figure 3.4.1-3. Temperature vs. Dylos 24-hour averaged data.

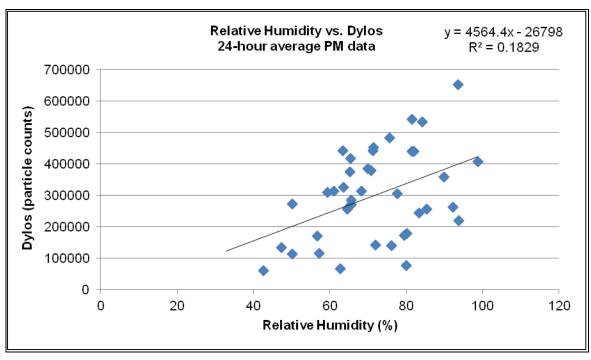
Figure 3.4.1-4. RH vs. Dylos 24-hour averaged data.

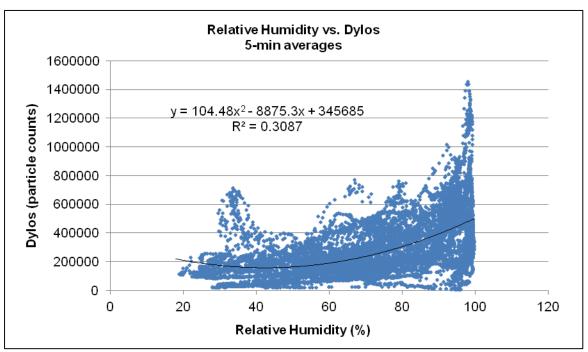
Figure 3.4.1-5. RH vs. Dylos (5-min averages).

RH fluctuates over the course of a day, necessitating a further look at the correlation between RH and sensor response at a 5-min averaged time resolution (Figure 3.4.1-5). The Dylos signal showed increased variability at high humidity. The upper bound of this variability appears to increase exponentially with RH. The production of artificially high results in the presence of high RH is a well-documented phenomenon with optically based particulate monitors<sup>11</sup>. As such, all data at RH greater than 95% were removed.

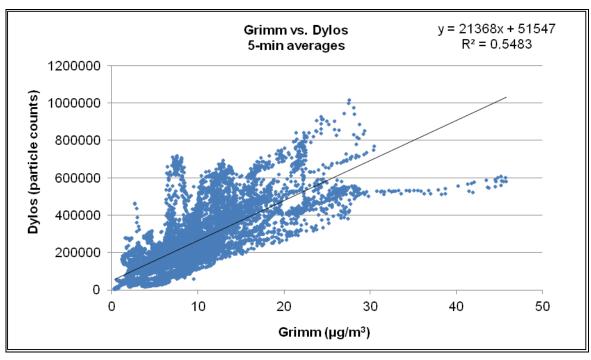
Figure 3.4.1-6. Grimm vs. Dylos (5-min averages).

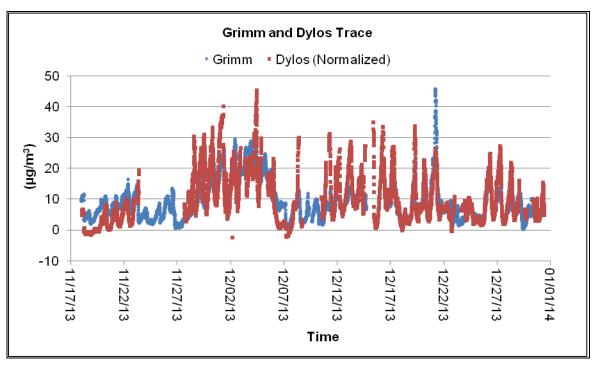
Figure 3.4.1-7. Grimm and normalized Dylos data (5-min averages) against time.

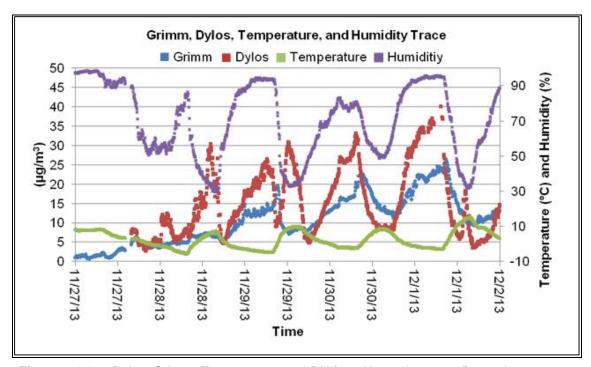
Figure 3.4.1-8. Dylos, Grimm, Temperature, and RH from November 27 to December 2, 2013.

A closer look at the data reveals discrepancies between the Dylos (normalized) and the Grimm FEM data (Figure 3.4.1-8). On the afternoons of November 28, November 29, and December 1, 2013, the Dylos showed significant and protracted spikes in particulates, whereas the Grimm indicated only very modest increases. The three spikes appear to correlate with a sudden increase in temperature and a drop in humidity, but this pattern was not consistently repeated in the rest of the data. These spikes might be related to meteorological phenomena that were not tracked in this experiment, but which feature sudden temperature and humidity changes. It is also possible that these spikes indicate a localized combustion event (e.g., idling

diesel engine) that produced large numbers of low-density particles affecting the device. Even so, we have no record of such an event occurring and it is only speculation as to one possible explanation.

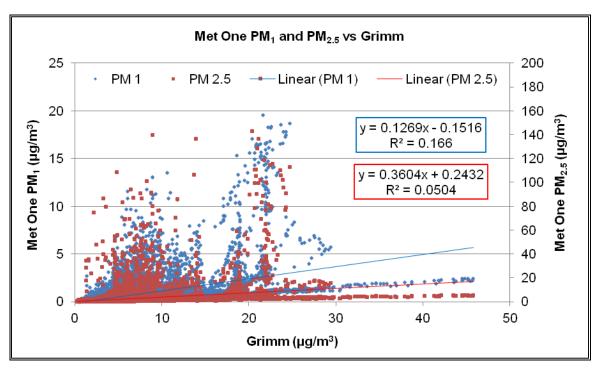
Figure 3.5.1-1. Grimm vs. Met One Model 831 PM<sub>1</sub> and PM<sub>2.5</sub> (5-min averages).

Early attempts to interpret the Met One data focused on the PM<sub>2.5</sub> channel as it was hypothesized that data from this channel would provide the best match with the Grimm PM<sub>2.5</sub> data. The PM<sub>2.5</sub> channel was found to contain many outliers in the form of sharp spikes on an order of magnitude or greater than the adjacent data. Many attempts were made to identify and remove outliers from the PM<sub>2.5</sub> data prior to calculating 5-min averages. Despite these efforts, 5-min averages of raw PM<sub>1</sub> data were found to have a coefficient of determination relative to the Grimm reference data more than three times greater than the PM<sub>2.5</sub> with the Grimm. Figure 3.5.1-1 clearly shows that compared to the PM<sub>1</sub> channel (which had no outliers removed), the PM<sub>2.5</sub> channel (which had many outliers removed) displayed significantly more spikes. For these reasons, only data for the PM<sub>1</sub> channel are reported in the remainder of this section as a best-case scenario.

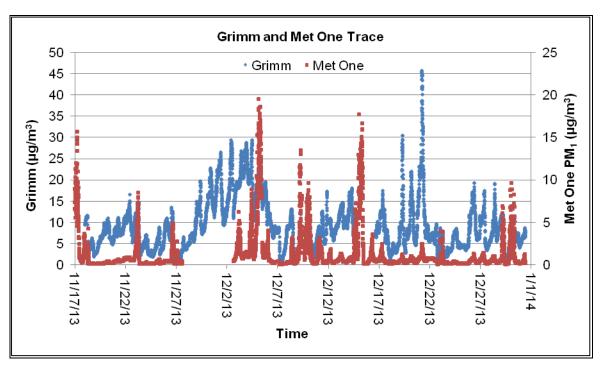
Figure 3.5.1-2. Grimm data and Met One Model 831 data over time.

Figure 3.5.1-2 shows that the responses from the Grimm and the Met One compare well. This comparison is further illustrated using Met One 24-hour averaged data plotted against the Grimm reference data (Figure 3.5.1-3) as well as temperature (Figure 3.5.1-4) and RH (Figure 3.5.1-5). The 24-hour averaged data suggests a correlation with the Grimm reference data, no correlation with temperature, and a strong correlation with humidity.

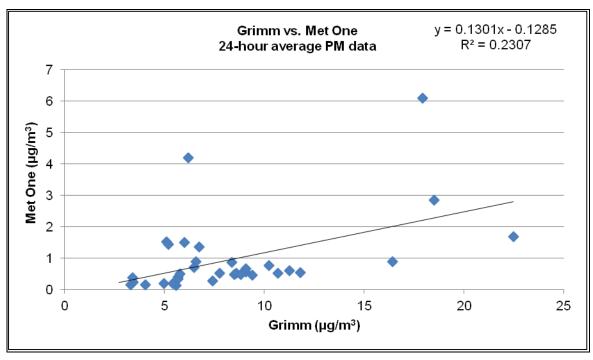
**Figure 3.5.1-3.** 24-hour time-averaged PM data comparing the Grimm reference sampler with the Met One Model 831 PM sensor.

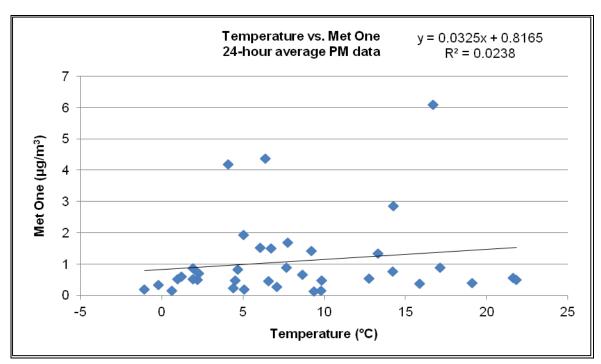
Figure 3.5.1-4. Temperature vs. Met One Model 831 24-hour averaged data.

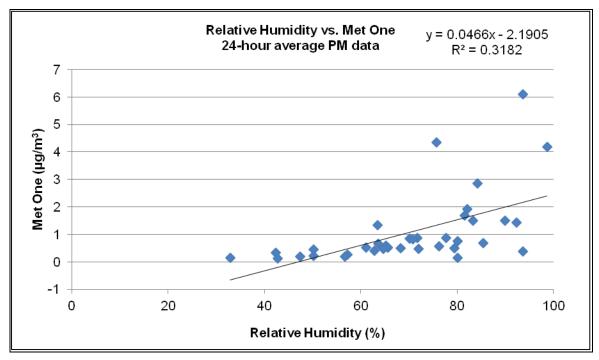
Figure 3.5.1-5. RH vs. Met One Model 831 24-hour averaged data.

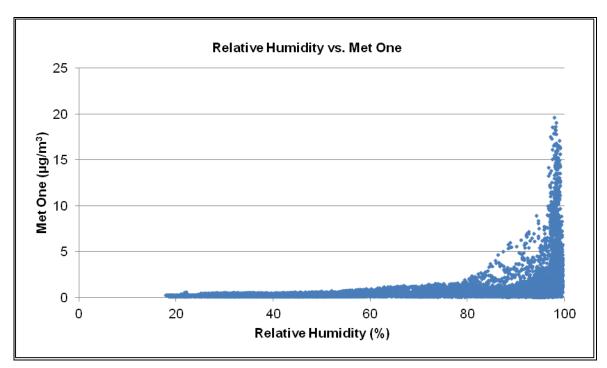
Figure 3.5.1-6. RH vs. Met One Model 831 (5-min averages).

As RH naturally fluctuated over the course of any given day, further investigation into the correlation between humidity and sensor response at the 5-min averaged time resolution was necessary. These results are shown in Figure 3.5.1-6. The Met One signal showed increased variability at high humidity. The upper bound of this variability appears to increase exponentially with rising relative humidity. As a result, all data taken at times when the relative humidity was greater than 90% were removed.

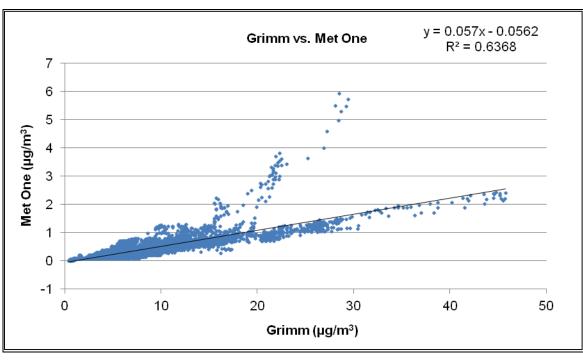
Figure 3.5.1-7. Grimm vs. Met One Model 831 (5-min averages).

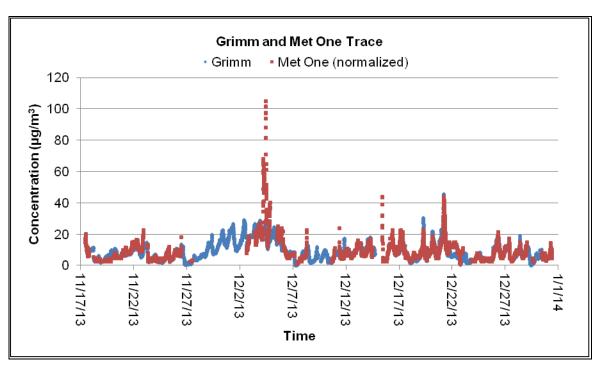
Figure 3.5.1-8. Grimm and normalized Met One Model 831 data (5-min averages) against time.

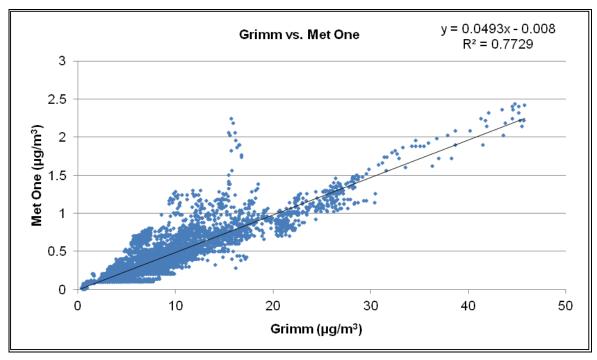
**Figure 3.5.1-9.** Grimm and Met One Model 831 data (5-min averages) with data from 04:00 to 14:00 on December 4 removed.

The spike seen on December 4, 2013 straddles data that were removed because they were taken at greater than 90% RH. It is possible there was an unrecorded drizzle or light rain event during this time that might have caused the spike. Consequently, all data collected between 04:00 and 14:00 on December 4, 2013, were removed. The scatter plot of the Met One data vs. the Grimm was remade in Figure 3.5.1-9 and renormalized in Figure 3.5.1-10.

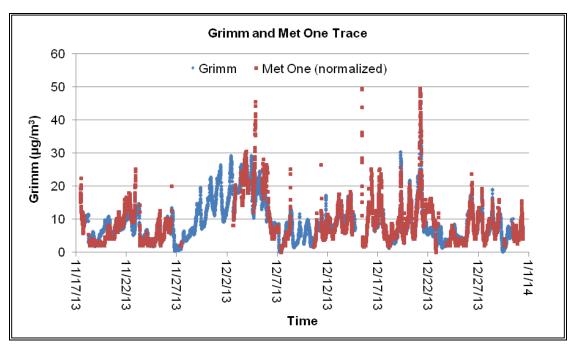
Figure 3.5.1-10. Grimm and renormalized Met One Model 831 data against time (5-min averages).

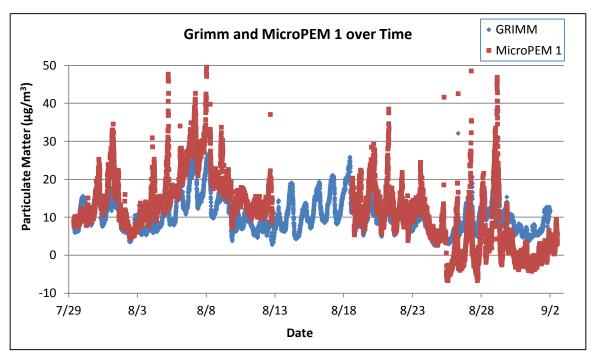
Figure 3.6.1-1. A trace of MicroPEM unit 1 and the Grimm over time.

Raw data was inspected visually for large outliers. Less than ten outliers were found and were removed manually. These outliers were highly fluctuating positive and negative signal responses, which appeared to be possibly electrical noise in nature. Data was then compiled into 5-minute block averages. Traces of each MicroPEM response over time overlaid with a trace of the Grimm over time are shown in Figure 3.6.1-1, Figure 3.6.1-2, and Figure 3.6.1-3.

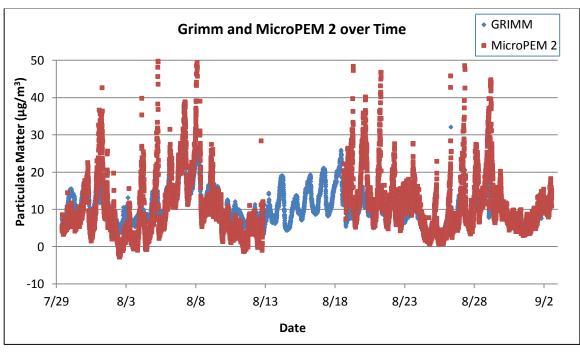
Figure 3.6.1-2. A trace of MicroPEM unit 2 and the Grimm over time.

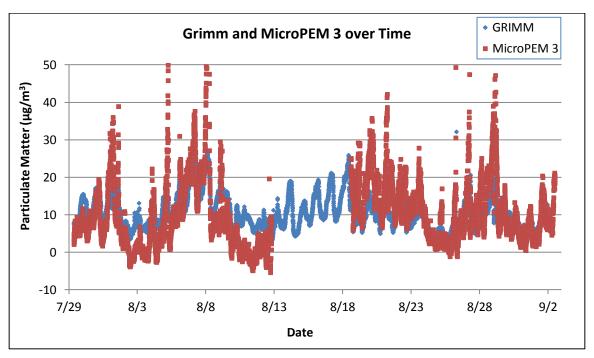
Figure 3.6.1-3. A trace of MicroPEM unit 3 and the Grimm over time.

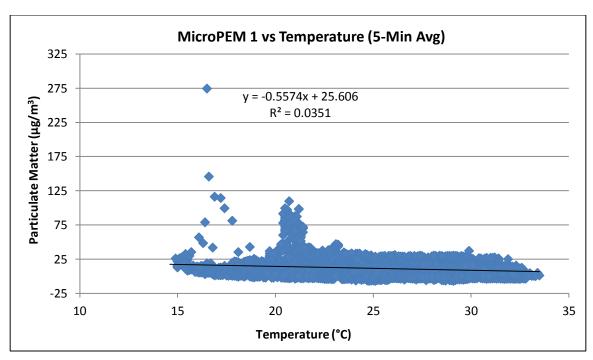
Figure 3.6.1-4. Scatterplot of MicroPEM 1 vs Temperature.

Figure 3.6.1-4 demonstrates that there is no correlation between the performance of MicroPEM 1 and temperature. This is in sharp contrast to the experiments conducted in the winter of 2013-2014 during which strong correlations were reported. Figure 3.6.1-5 demonstrates that relative humidity has no effect on the MicroPEM's signal below 90% RH. There is a significant cluster of aberrantly high data points when RH > 94%.

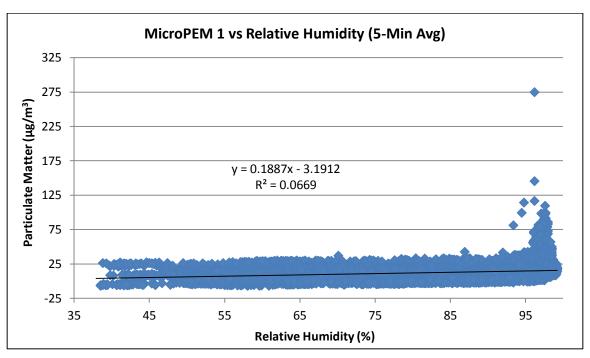
Figure 3.6.1-5. Scatterplot of MicroPEM 1 vs Relative Humidity

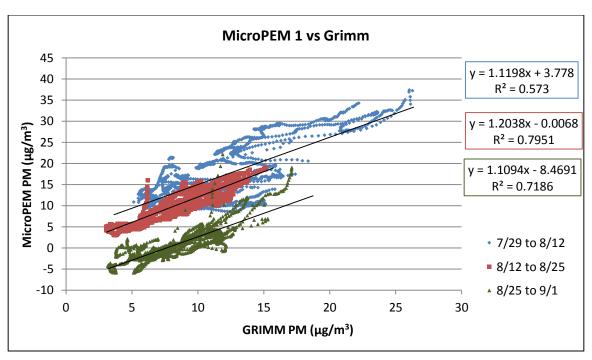
**Figure 3.6.1-6.** Scatterplot of MicroPEM 1 vs the Grimm. The data has been divided into three time periods following zeroing of the unit.

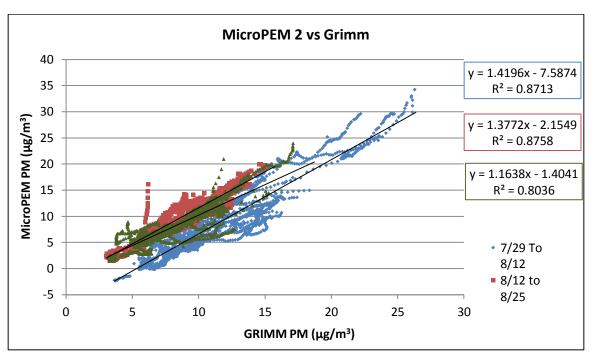
**Figure 3.6.1-7.** Scatterplot of MicroPEM 2 vs the Grimm. The data has been divided into three time periods following zeroing of the unit.

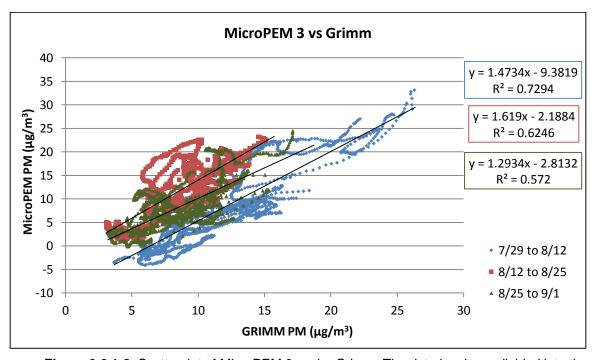
**Figure 3.6.1-8.** Scatterplot of MicroPEM 3 vs the Grimm. The data has been divided into three time periods following zeroing of the unit.

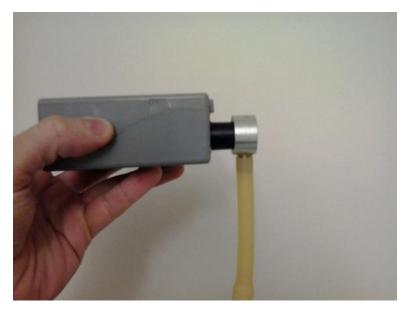
Figure 3.6.1-9. RTI MicroPEM with zero air filter attached.

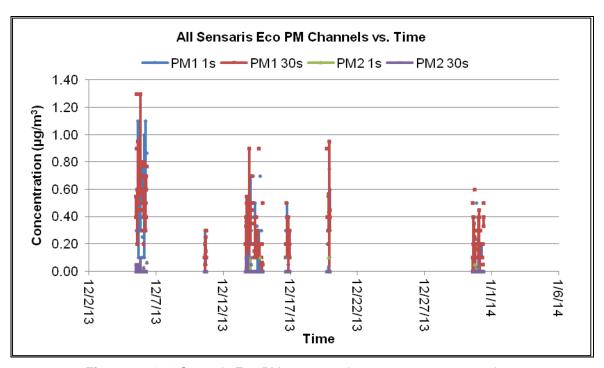
Figure 3.7.1-1. Sensaris Eco PM concentration measurements over time.

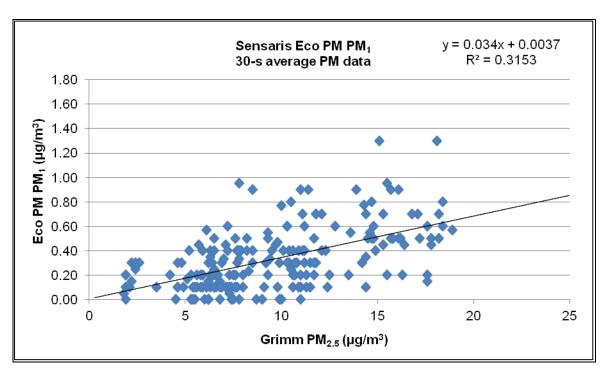
**Figure 3.7.1-2.** 30-s time-averaged PM data comparing the Grimm reference sampler with the Eco PM sensor.

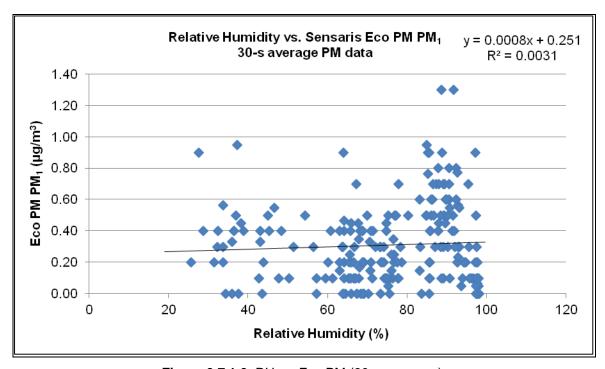
Figure 3.7.1-3. RH vs. Eco PM (30-s averages).

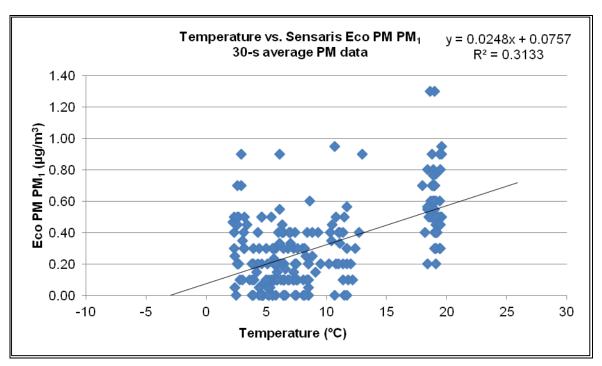
Figure 3.7.1-4. Temperature vs. Eco PM (30-s averages).

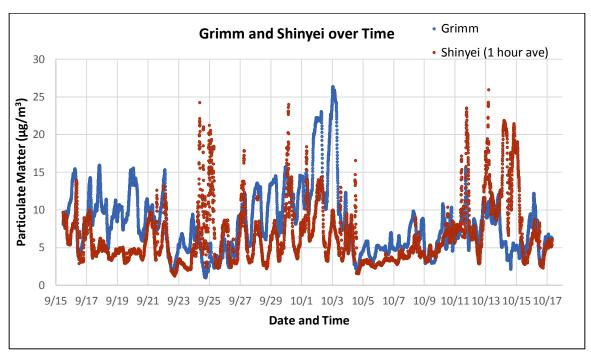
Figure 3.8.1-1: A trace of the Shinyei and the Grimm over time.

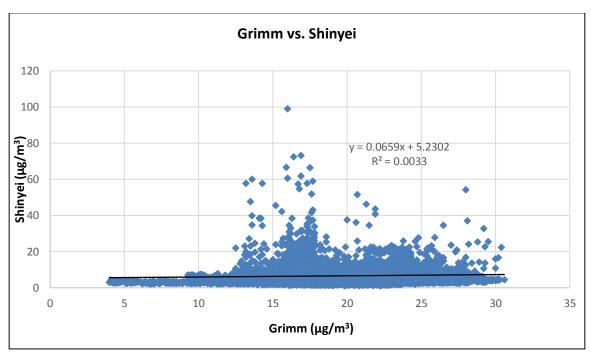
Figure 3.8.1-2: Grimm vs. Shinyei (5-min averages).

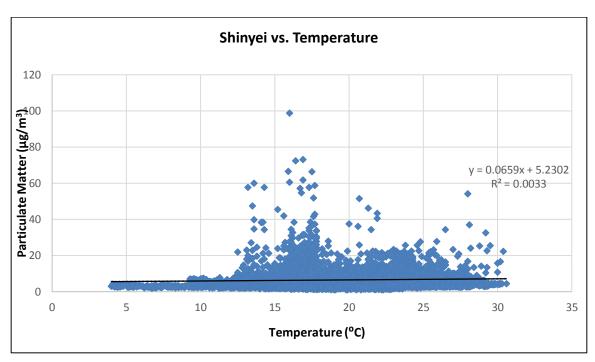
Figure 3.8.1-3: Scatterplot of the Shinyei vs Temperature.

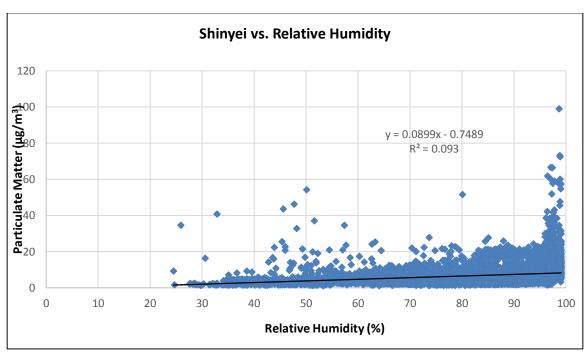
Figure 3.8.1-4: Scatterplot of the Shinyei vs Relative Humidity.

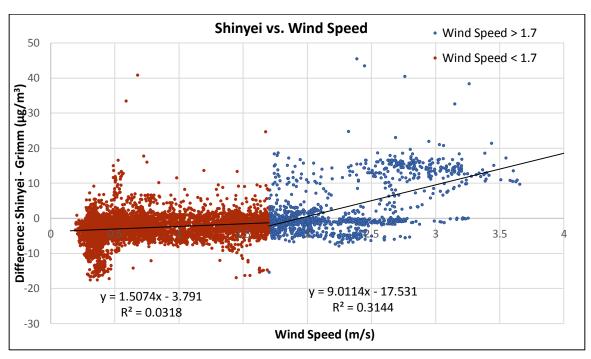
**Figure 3.8.1-5:** Scatterplot of the Shinyei vs Wind Speed. The graph is broken into two parts to illustrate the change in correlation at 1.7m/s wind speed.

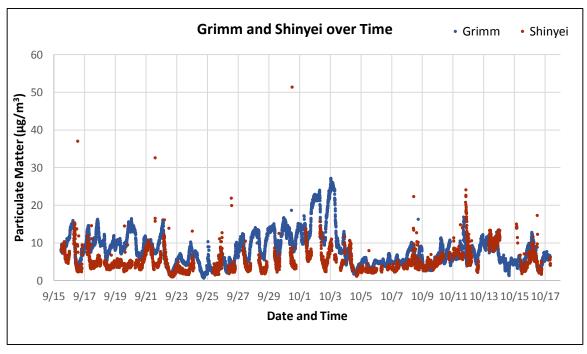
**Figure 3.8.1-6:** A trace of the Shinyei and the Grimm over time. Data affected by high humidty (>95%), winds (> 1.7m/s in a one-hour average), or within one hour of measure rainfall has been removed.

Figure 3.8.1-6 is a trace of the Shinyei data with high humidity, high wind, and rain removed alongside the Grimm data over time. Figure 3.8.1-7 is a scatterplot of the Shinyei vs the Grimm.

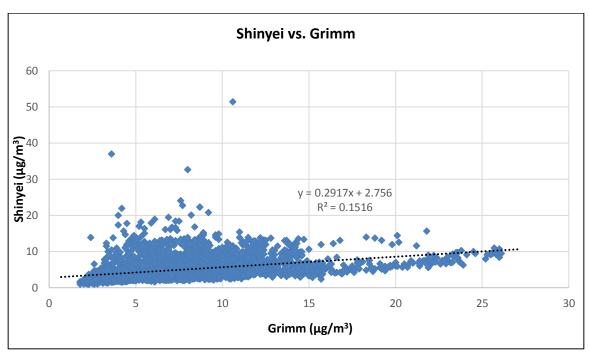
Figure 3.8.1-7: Scatterplot of the fully processed Shinyei data vs the Grimm.
